# M.P. Rathke restores 1897 Möller Opus 188

Zion's Lutheran Church, East Germantown, Indiana

By Michael Rathke

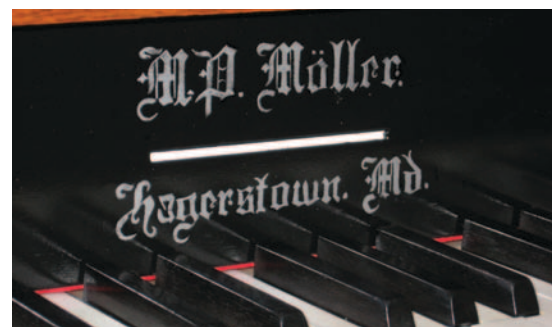
1. Nameboard (Photo credit: Nicholas Ringwald)

The mechanical restoration was labor-intensive but relatively straightforward. We discovered that sponzil failure had been caused not only by the common condition of overheated, dry winter air, but also by sagging at midpoint of both manual windchests owing to glue-line creep. Grid sponzils had thus opened on their undersides like the folds of an accordion in response to 115 years of gravity. After patching and regluing the sponzils, we provided reinforcement to the grid rails of both manual chests to prevent future deflection and to ensure that sponzil repairs would remain permanent. Keyboards were cleaned, flattened, polished, and rebushed; key tails were refelted and releathered. The Swell to Great coupler was comprehensively refurbished. Drawknobs were cleaned and relacquered, stop jamps were rebushed, and a purpose-made rotary blower switch (replacing a massive and unsightly industrial knife switch) was manufactured and applied to the old Bellows Signal stopknob. Kristen Farmer of Winston-Salem, North Carolina, was engaged to strip the many layers of flat black paint that had been applied to the nameboard and to carry out a painstaking restoration of the original silver-leaf stenciling (Photo 1). Five components required remanufacturing, either in full or in part:

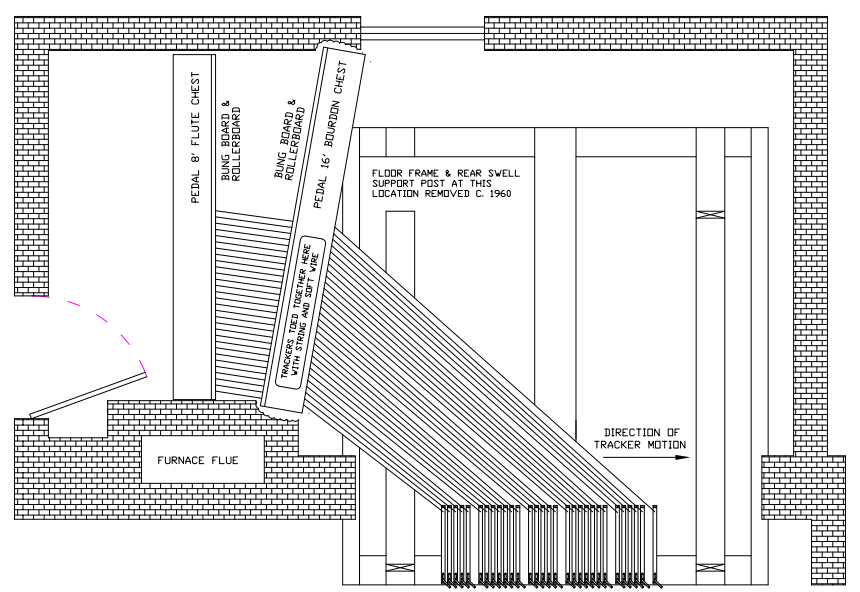
**Sketch B: Pedal key action as modified during 1933 move** (Photo credit: Michael Rathke)

Several things soon became apparent. First, the 1933 relocation from St. Paul's Lutheran in nearby Richmond—carried out by "two farmers and a mechanic," according to local tradition—had begun the instrument's woes. The movers had clearly been competent general craftsmen, but they appear not to have been trained organbuilders. Second, the masonry chamber within which some two-thirds of the organ resided was not well sealed, leaking cold air in winter and hot air in summer, along with the odd bit of blown snow and rain. Third, although the chamber tone opening was more than ample and allowed good tonal egress, the chamber itself was almost too small for the organ it enclosed. The pedal chests had been wedged in at contrary angles, with key action run cross-lots and cobbled together from an assortment of wood tracker stock and soft copper wire. Fourth, the movers had provided absolutely no tuning or maintenance access. To carry out such basic operations as adjusting key action nuts required removal of most of the pedal pipes; to tune the Oboe necessitated either the removal of façade pipes or a precarious climb high above the pedal division.

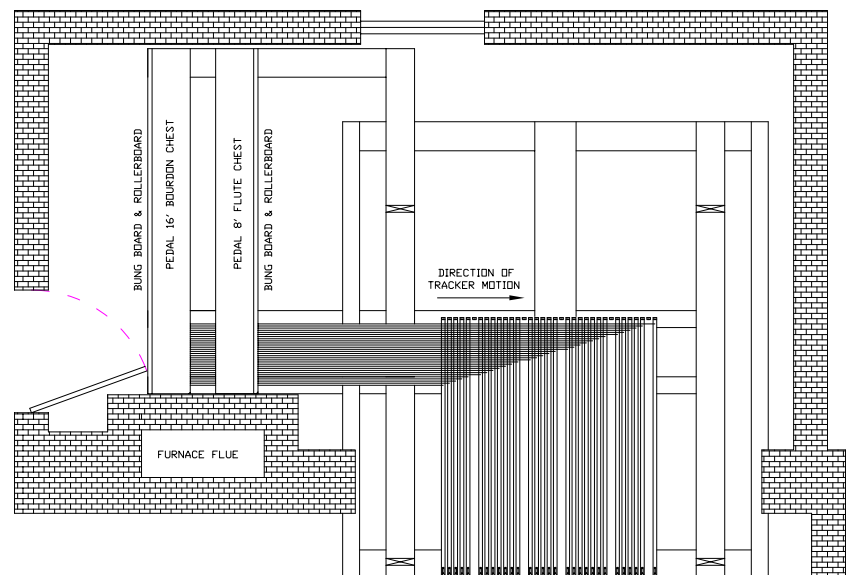
**Sketch C: 2013 reconstructed pedal key action and floor frame** (Photo credit: Michael Rathke)

**5. Replica reservoir placement and Great wind duct re-routing**—During its time at Zion's, the Möller's supreme drawback had been a lack of maintenance access. The general culprit was a narrow (8'2") chamber opening, compared with the width of the organ's main internal structure (8'0"), but specific obstacles included the location and orientation of both the original double-rise reservoir and the Great wind duct.

The 2013 solution was twofold. First, we turned the new reservoir 90 degrees from its original orientation, which

allowed us to respect the essential layout of the original wind system while simultaneously opening a clear access path into the organ. (Sketch C) The end-on positioning of the new bellows will also make possible its easy removal for future re-leathering, as opposed to the crosswise orientation of the original, whose zero-clearance installation in 1933 surely contributed to its eventual demise.
